ANALYSIS OF HYDRAULIC AND GEOMORPHIC CONDITIONS CAUSING RAILWAY EMBANKMENT
BREACH DUE TO INUNDATION FLOW

SYNOPSIS

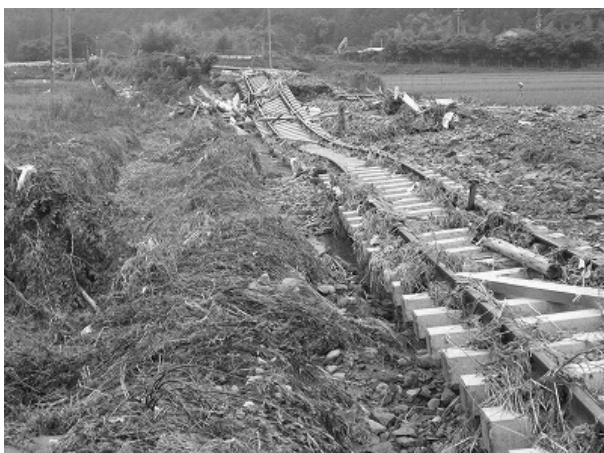
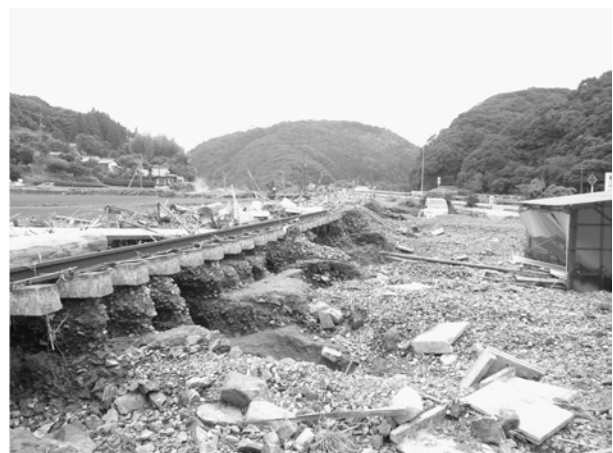
(a) August 2009, in Hyogo, Japan

(b) July 2010, in Yamaguchi, Japan

Fig. 1 Damage to the embankments on a floodplain

Damage to railway embankments caused by inundated flows occurred mainly along the area where the Sayo River and Kishin Line run parallel in the outskirts of Sayo-cho district, in which rainfall was extremely concentrated. Most of the damage occurred within the reach of about 13 km between Harimatokusa and Mimasaka-Doi Stations; the damages are ballast flushed away at 56 points, 13 slope failures and sediment influx and 9 severe breachings of embankment, etc. It should be noted that damage to ballasts and embankments took place to a greater degree between Sayo and Kozuki Stations since inundated flow directly hit railway lines in this area. Fig.3 shows locations of the railway damage as filled circles and the Sayo River and the Kishin Line. The numbers beside the filled circles indicate the kilopost of the Kishin Line. According to the field research (Kaneko (4)), the heaviest damage was observed at 49.2 kp, where an embankment about 2 m in height was washed away over 140 m and ballasts were damaged over 60 m beside the embankment breached area. As a result the railways became twisted and suspended because of the hydrodynamic forces due to the inundated flow as shown in Fig.1a.
